Laboratory testing of a full scale masonry arch bridge

Vasilis Sarhosis

School of Civil Engineering, University of Leeds

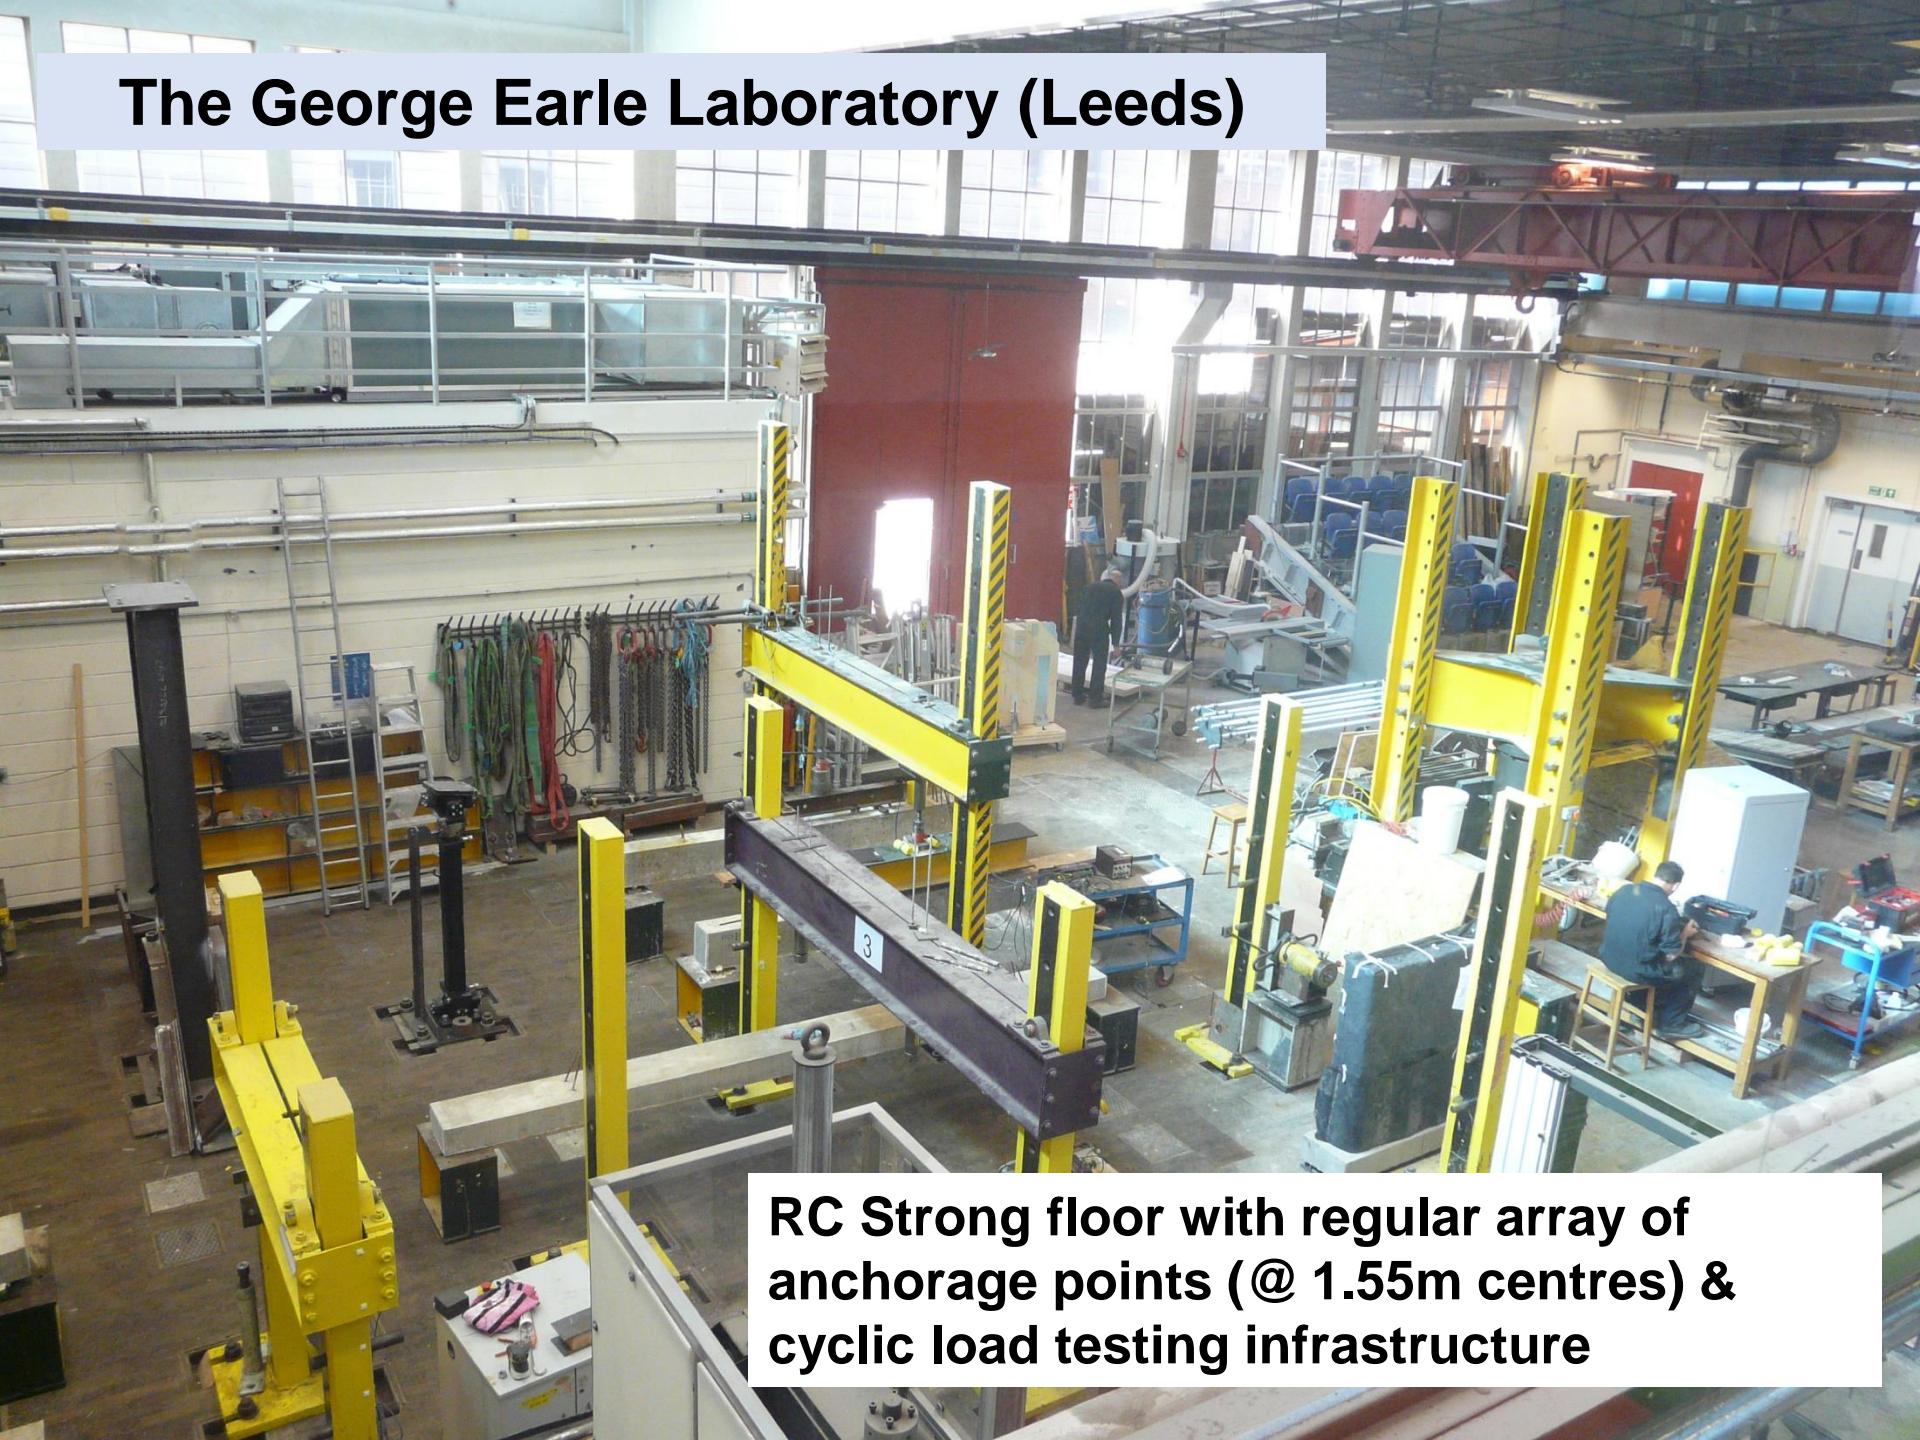
The George Earle Laboratory (Leeds)

RC Strong floor with regular array of anchorage points (@ 1.55m centres) & cyclic load testing infrastructure

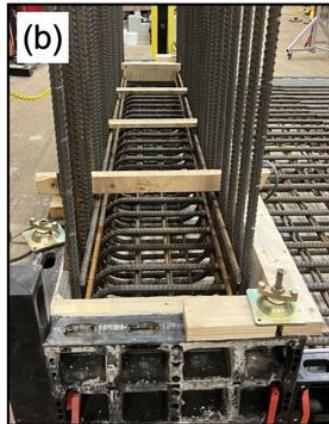
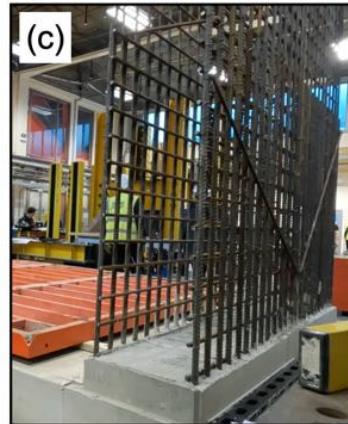
Construction of RC base slab with end walls

- **Dense reinforcement arrangement** adopted for the RC base slab and end walls to enhance stiffness.
- **Thickness of base slab = 300 mm;**
thickness of walls = 540 mm.
- C30-grade concrete used for construction.

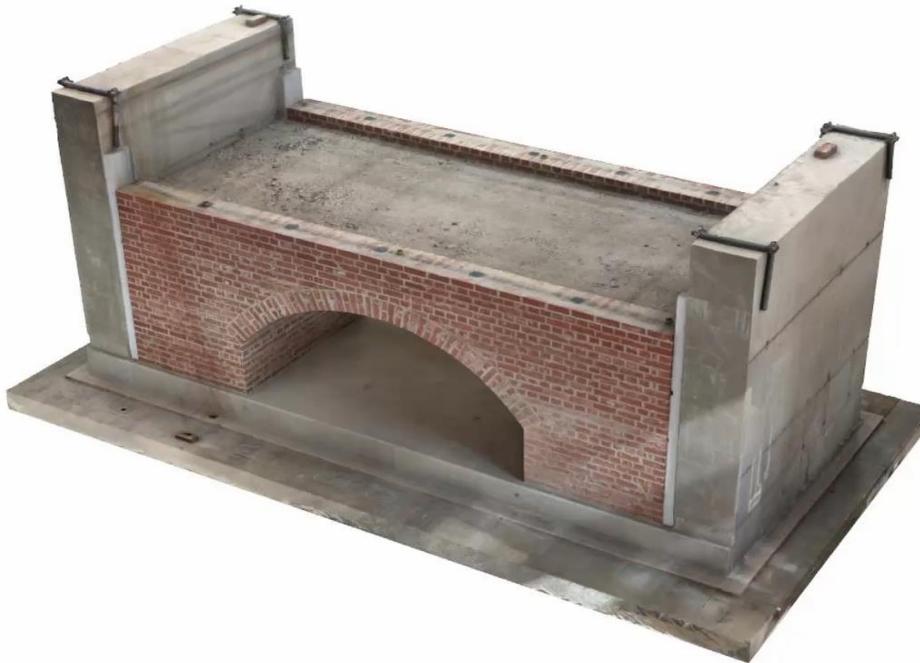
(b) Abutment and lower part of spandrel walls

(c) Single-ring arch barrel with a header bond (215 mm thick)

(d) One and half brick thick spandrel wall (English bond)

(e) Arch-spandrel wall connection

Note: to ensure consistency, and minimize variability due to workmanship, the bridge was constructed using a single bricklayer

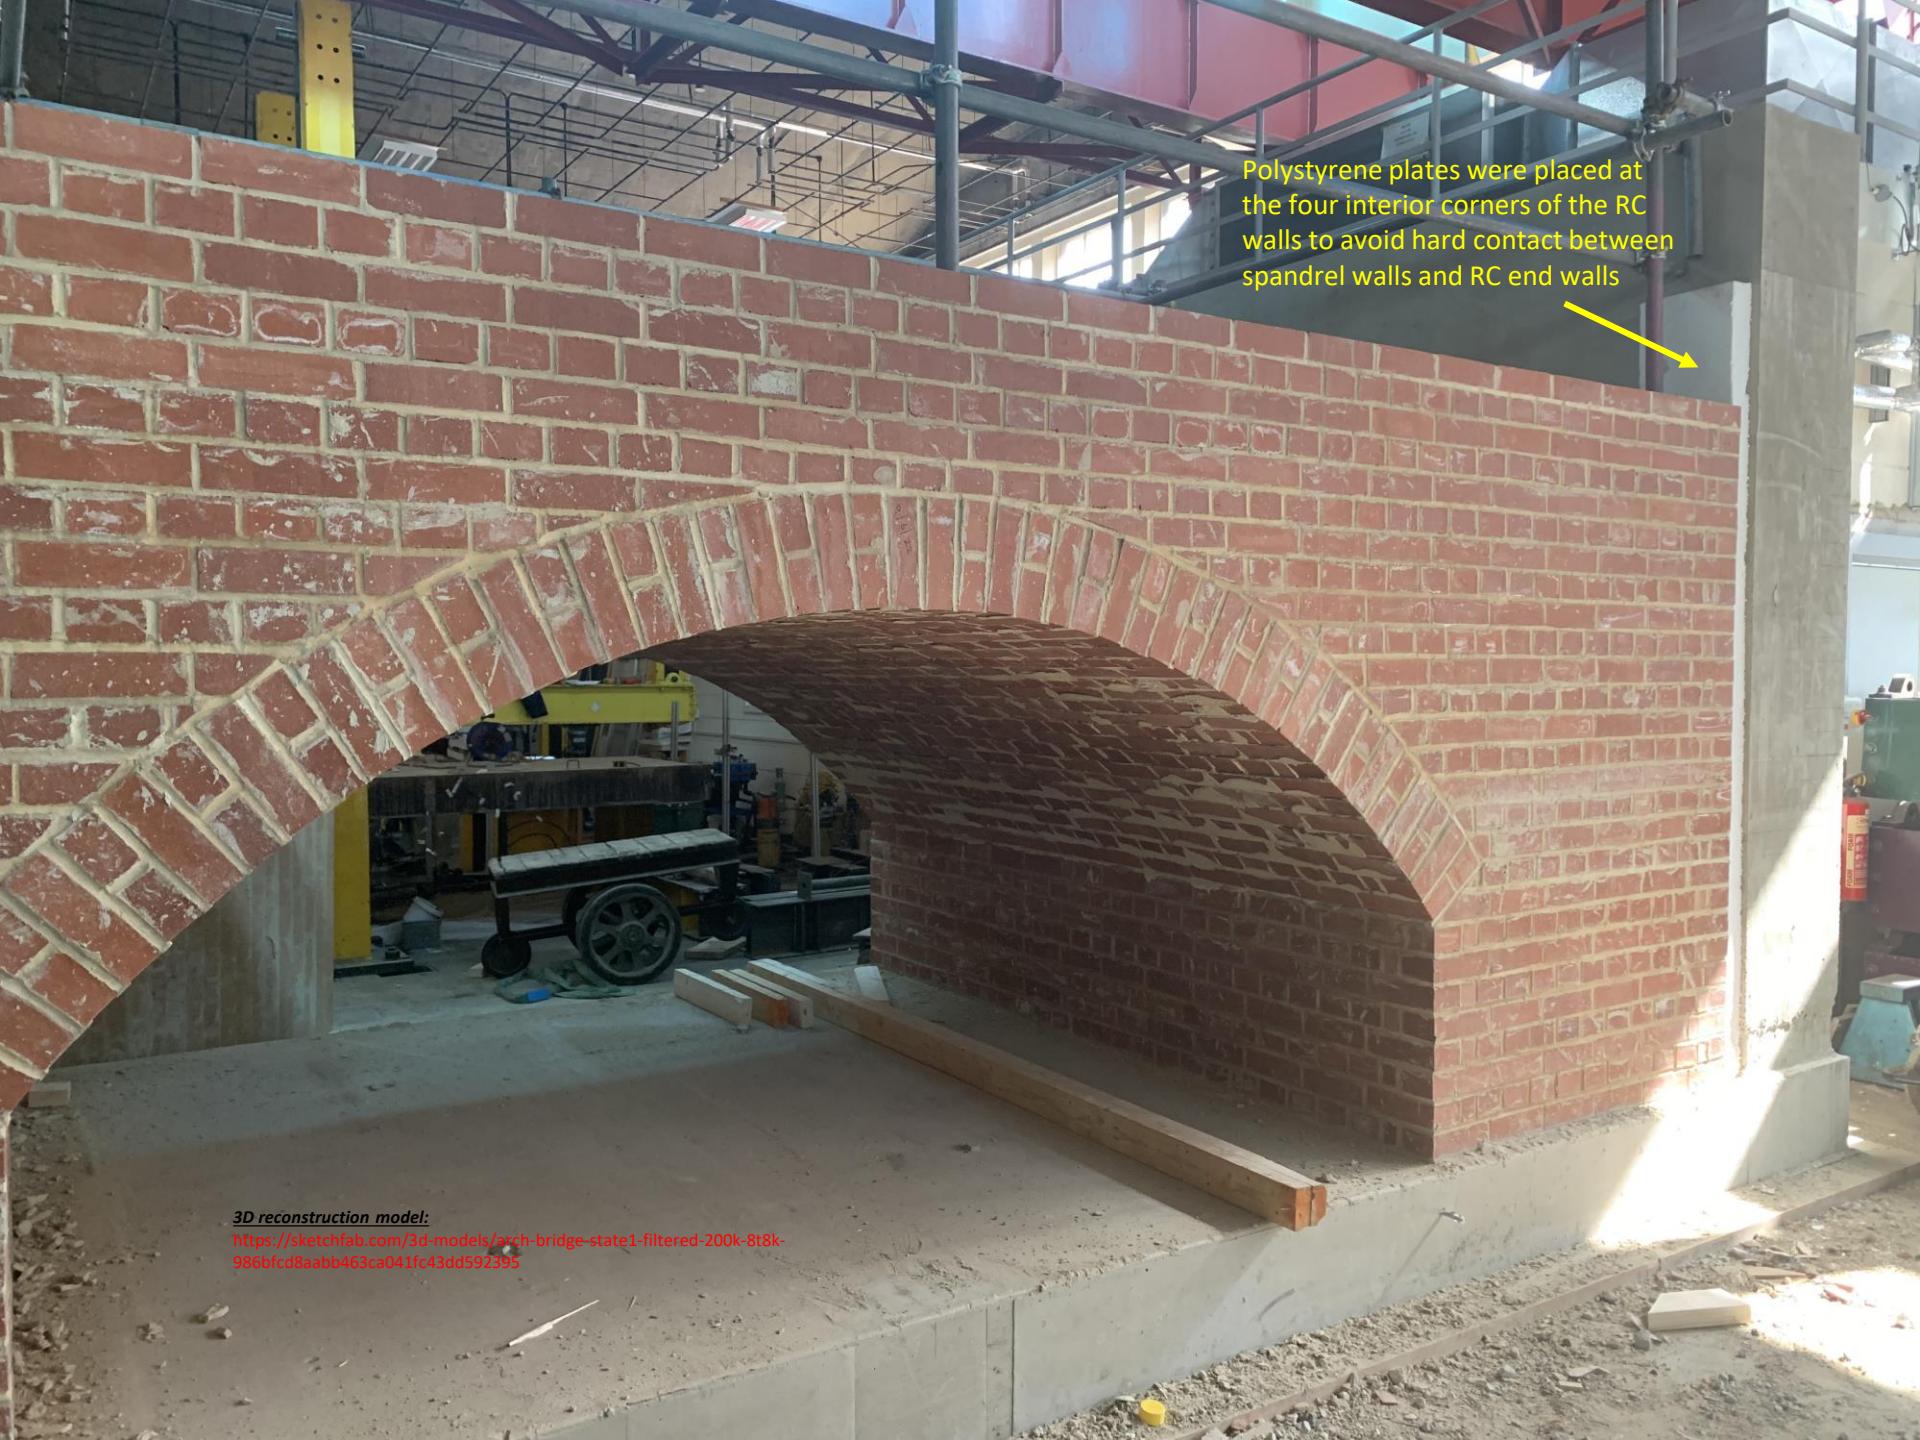
Polystyrene plates were placed at the four interior corners of the RC walls to avoid hard contact between spandrel walls and RC end walls

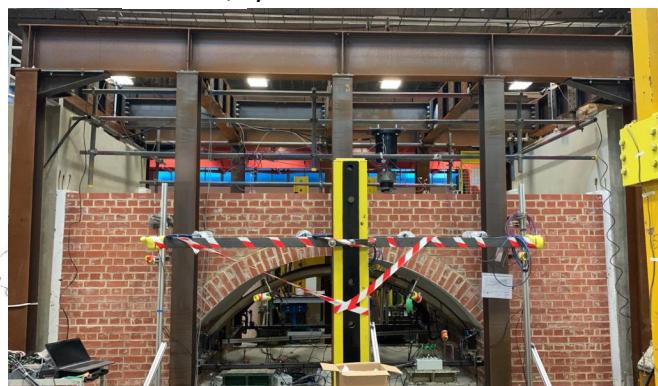
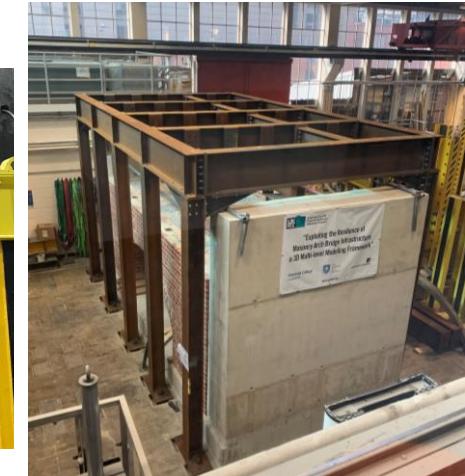
- A steel reaction frame was specifically designed for mounting the hydraulic actuator and applying vertical static/cyclic loads

- Steel frame was rigid
- Beams and columns were steel I-sections.
- Actuators can be mounted at the short beams
- The short beams can move transversely for the application of various loading scenarios;

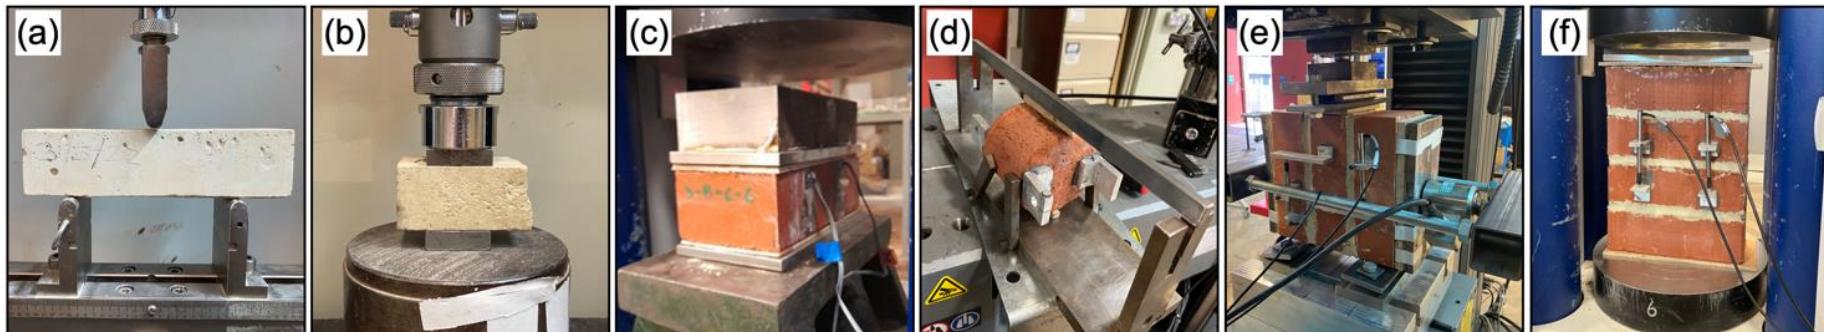
Small-scale testing for material characterisation

(a) three-point bending tests on mortar prisms; (b) compression tests on mortar cubes; (c) compression tests on bricks; (d) Brazilian tests on brick cylinders; (e) triplet shear tests; (f) compression tests on masonry prisms.

- All specimens constructed at the same time as the construction of the masonry arch bridge, and tested at the time of testing the bridge i.e. same curing conditions.
- Designed in close association with colleagues developing numerical models

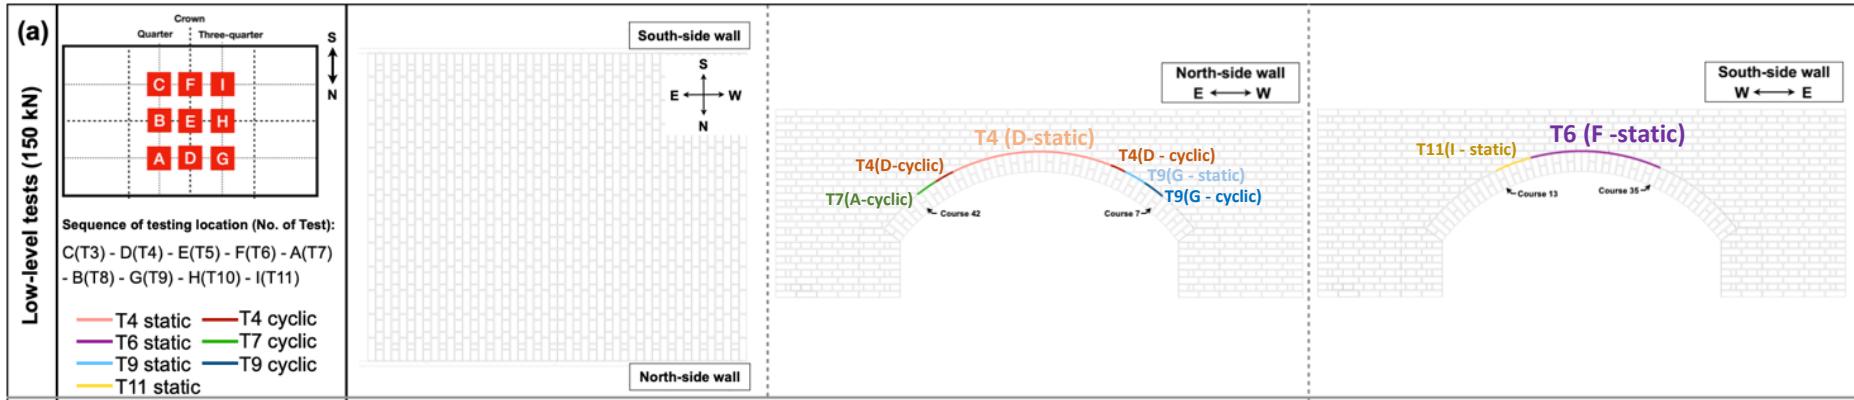
Low-level: 150 kN

- At low level of loads, cracks were very thin (hairline cracks).
- With the removal of the load, cracks closed.
- First crack observed when load applied at the crown close to the spandrel wall (Point D).
- The first crack was a detachment of the arch ring from the spandrel wall.

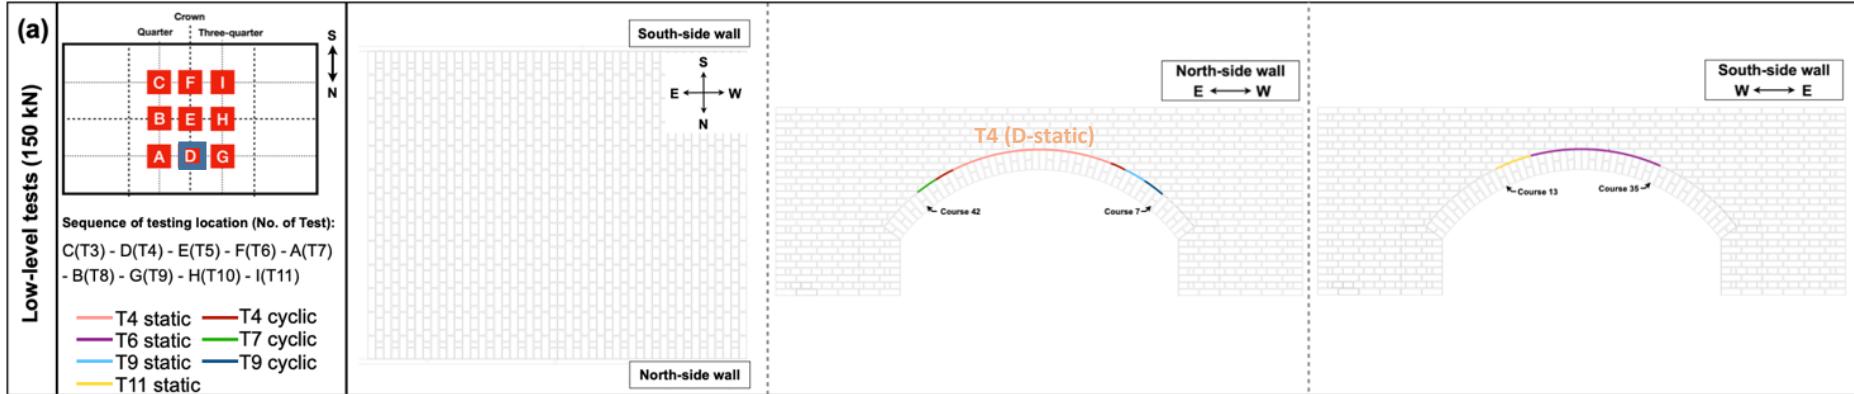
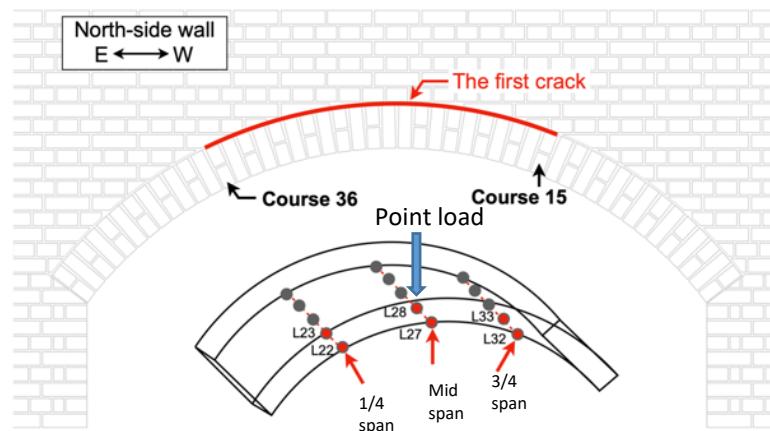
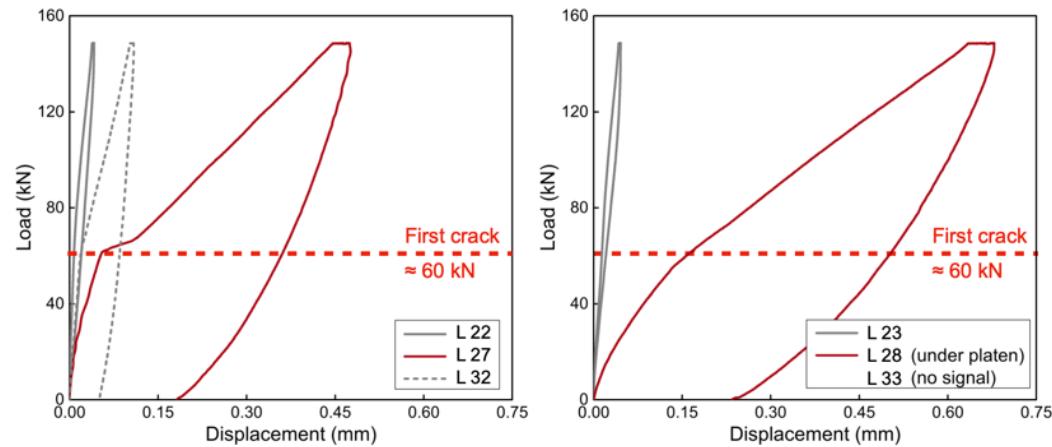
- **The first crack:** separation between the arch barrel and spandrel wall
- **Loading location:** Point D
- **Cracking load:** approximately 60 kN

Displacement close to the edge of the arch ring (L27)

Displacement under point load (L28)

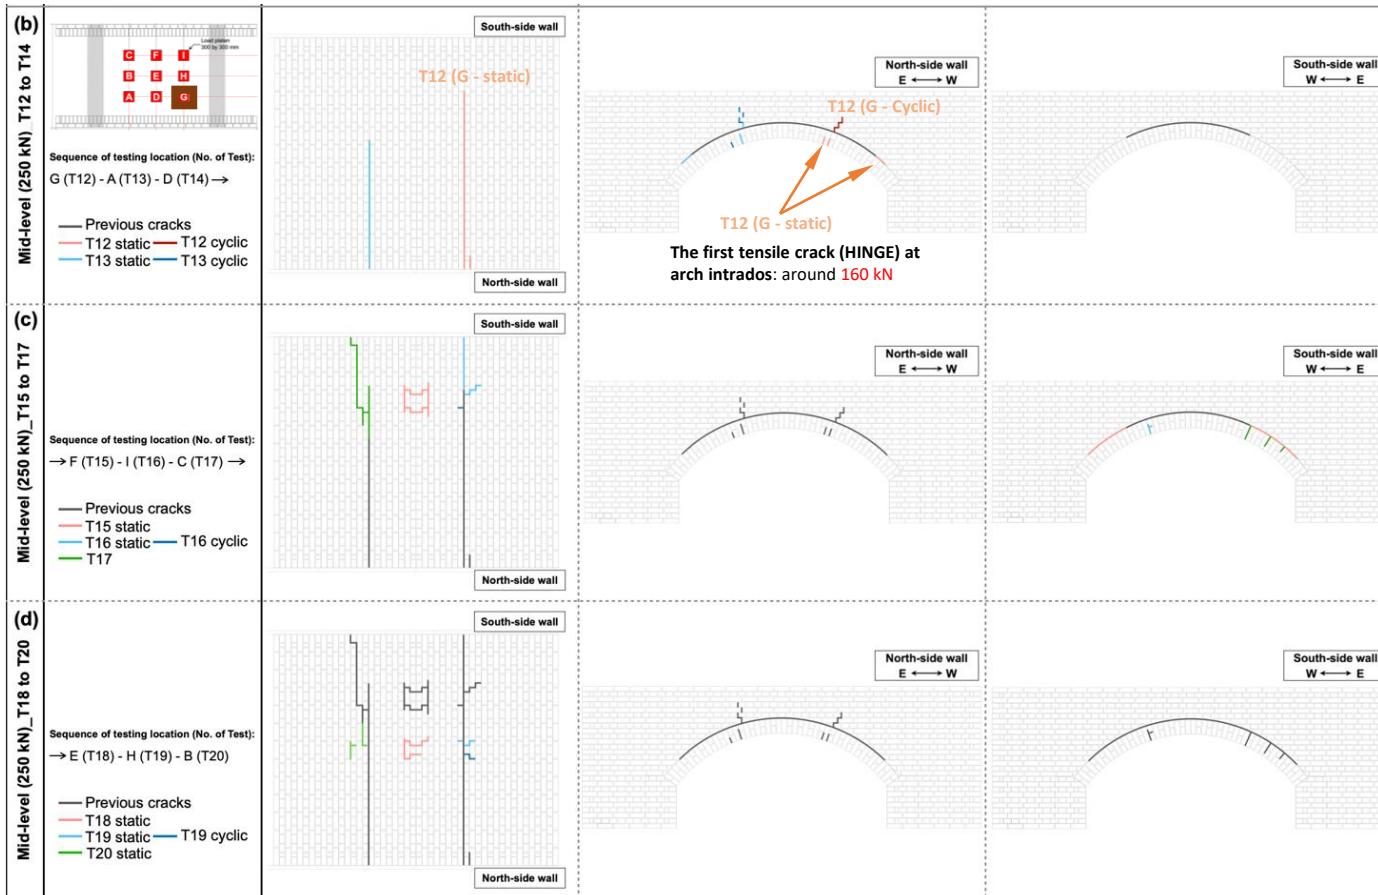
- Mid-level: 250 kN (less than 50% of ULS)

Diagonal crack
at spandrel wall
(G location)

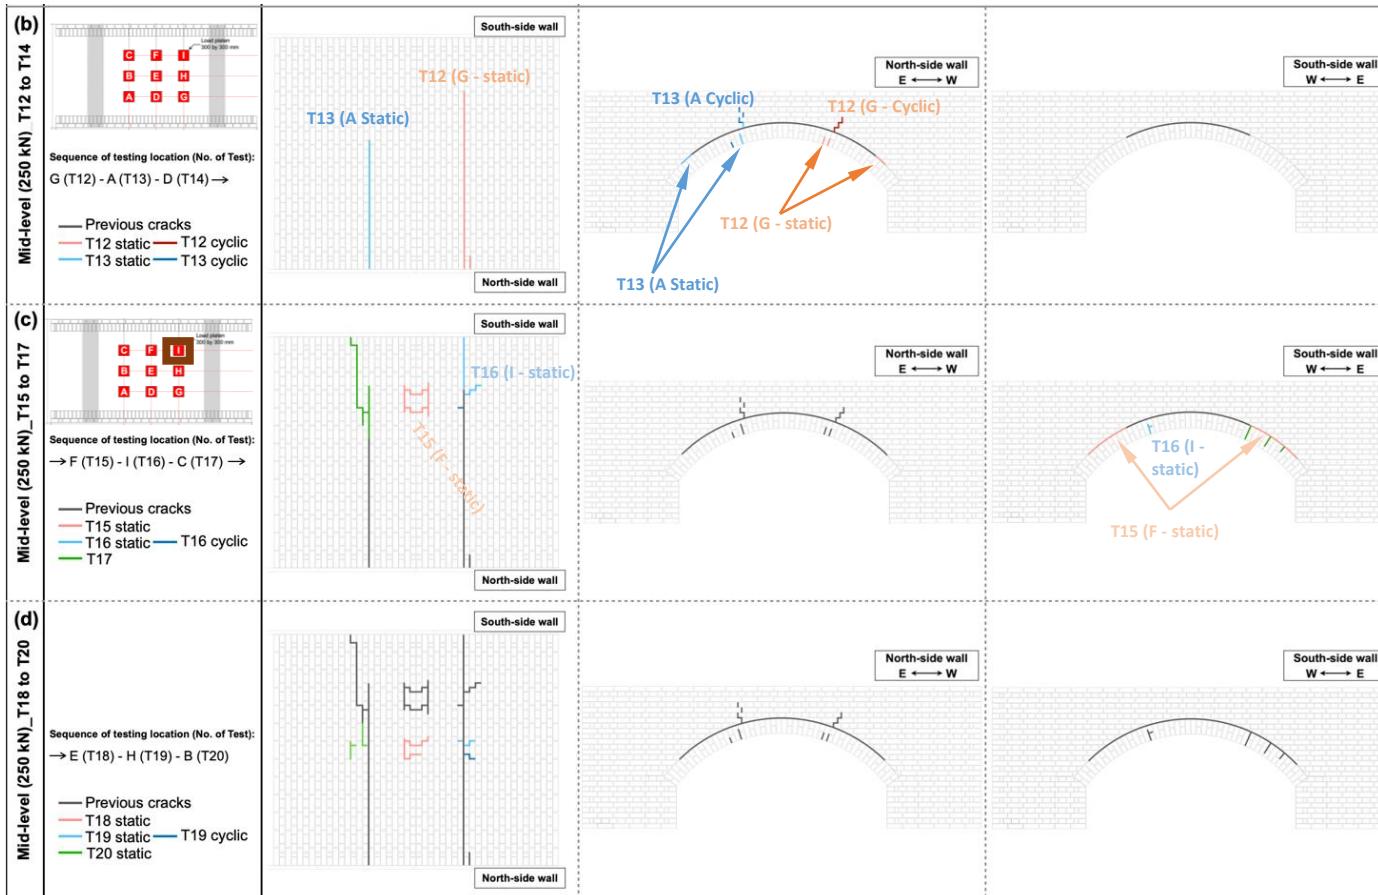
Diagonal crack
at spandrel wall
(G location)

Tensile crack
at arch intrados

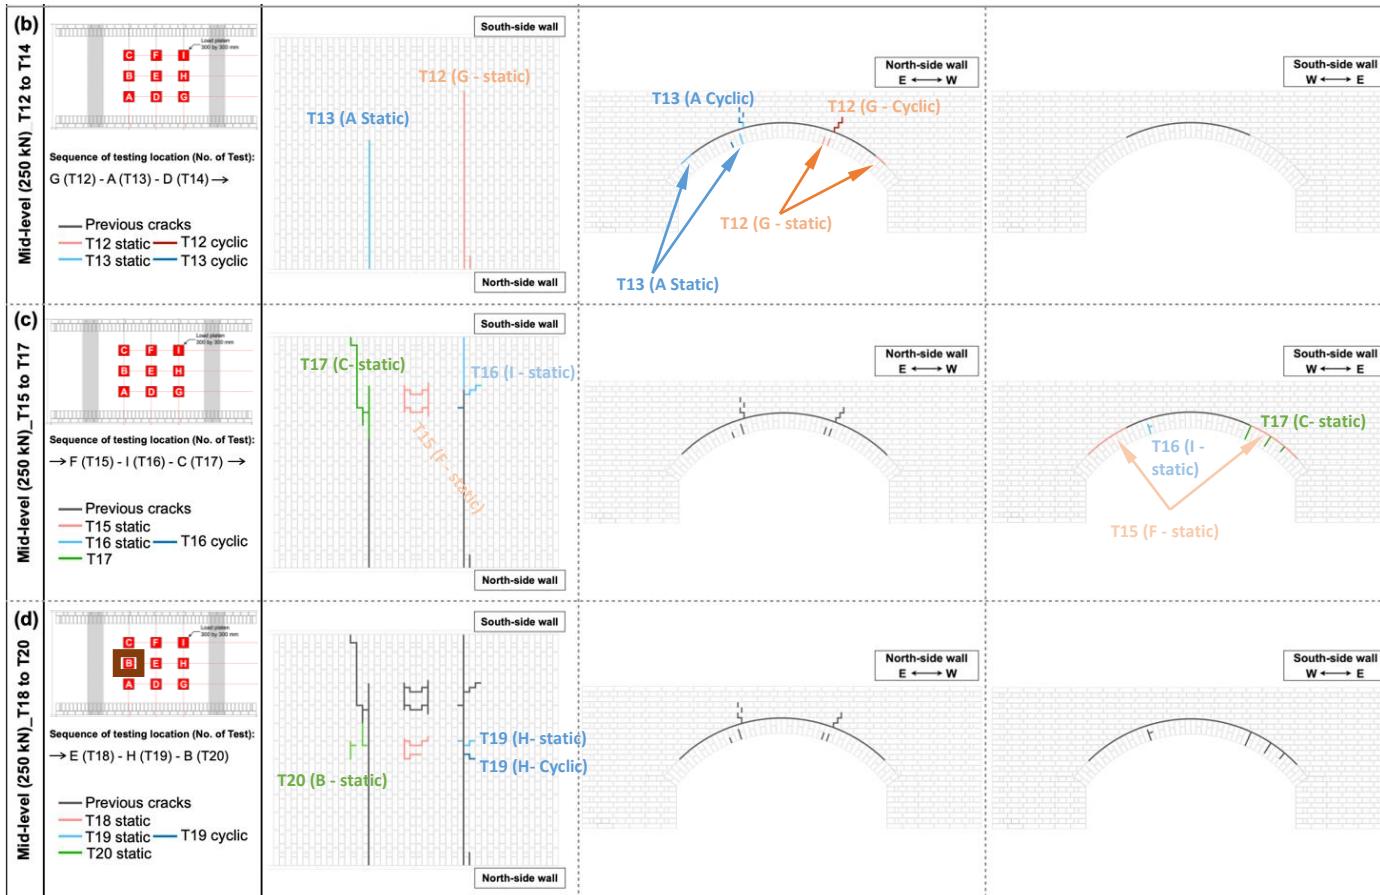
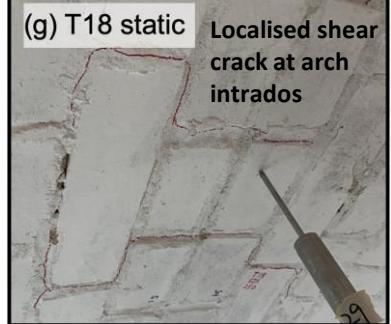
Diagonal crack at spandrel wall (G location)

Tensile crack at arch intrados

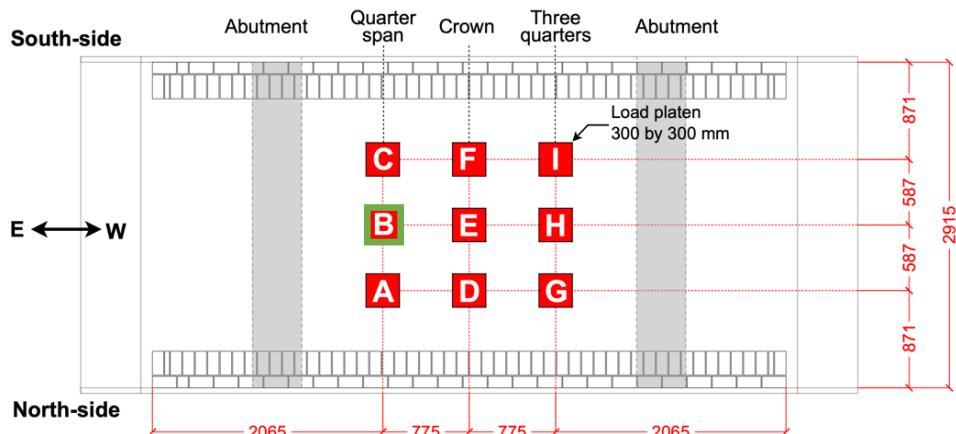
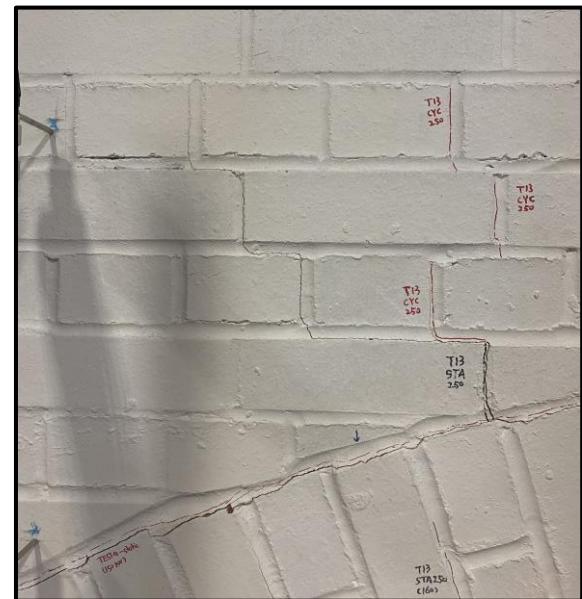
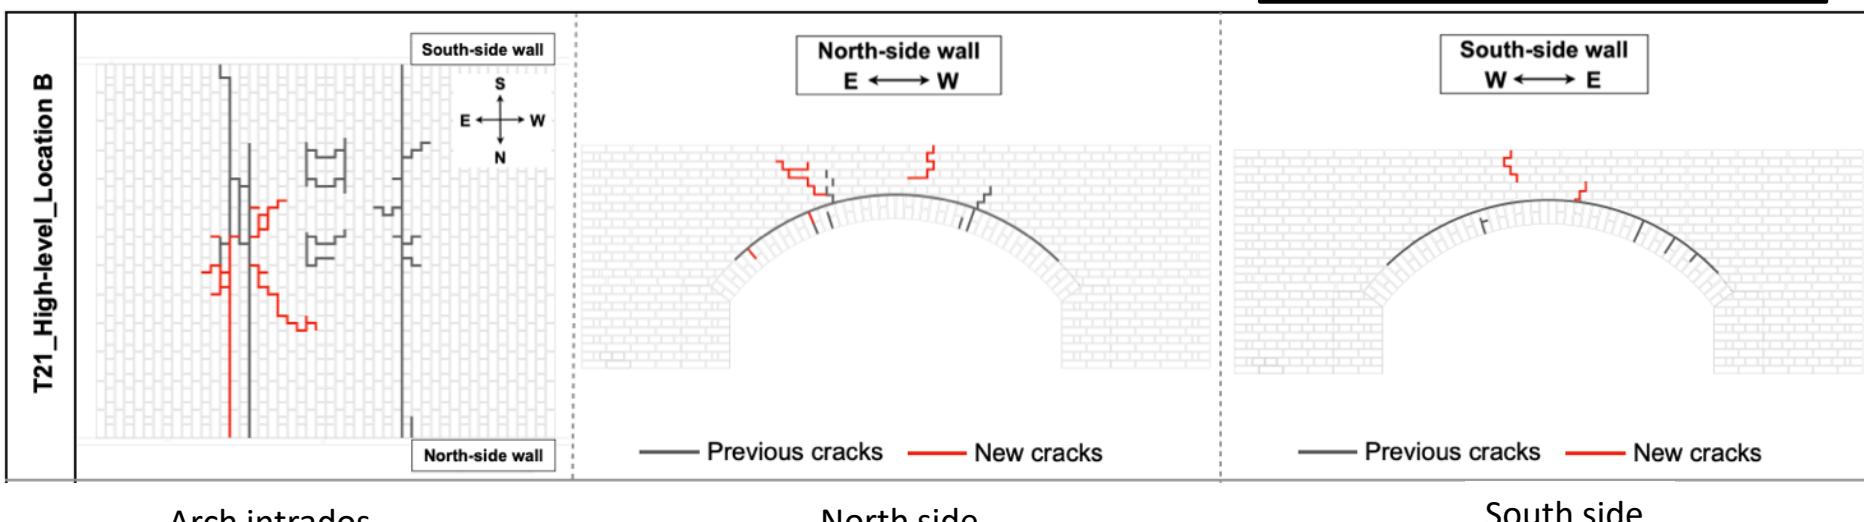
- High-level: 560 kN**

Propagation of diagonal cracks at spandrel wall

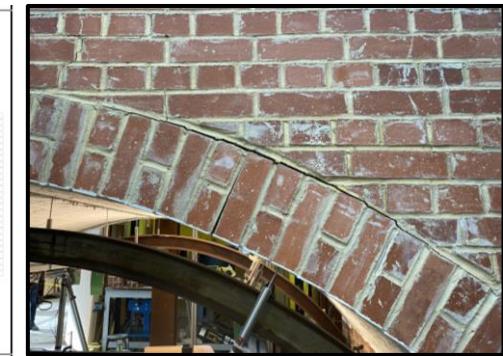
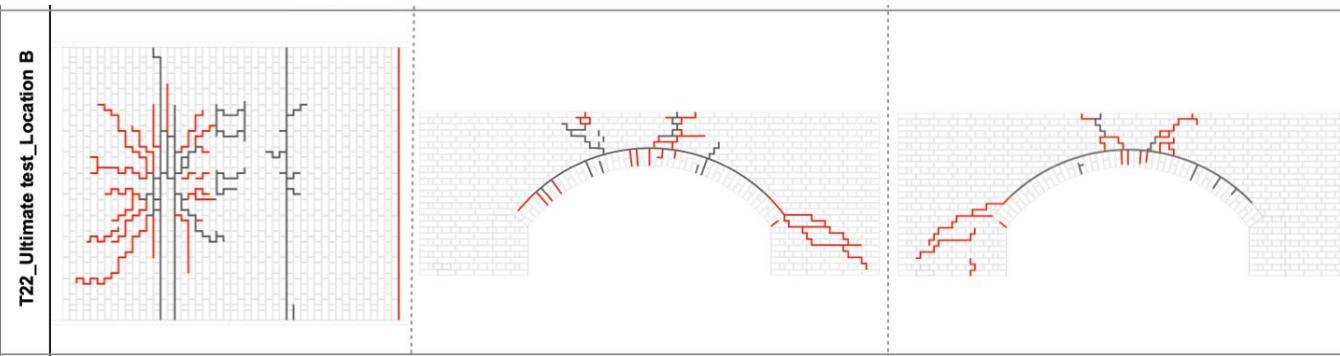
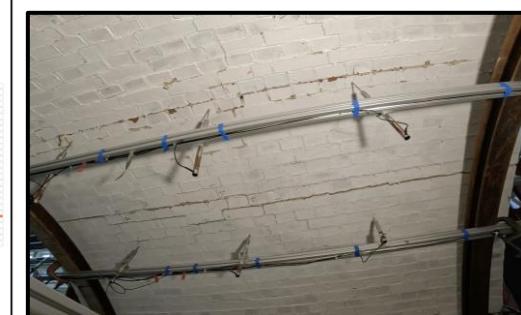
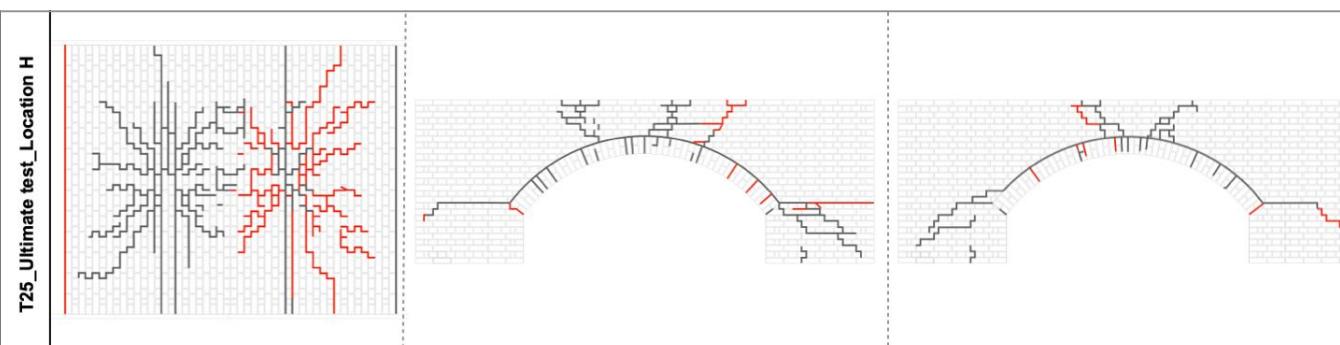
Failure-level tests

Hinge under loading location

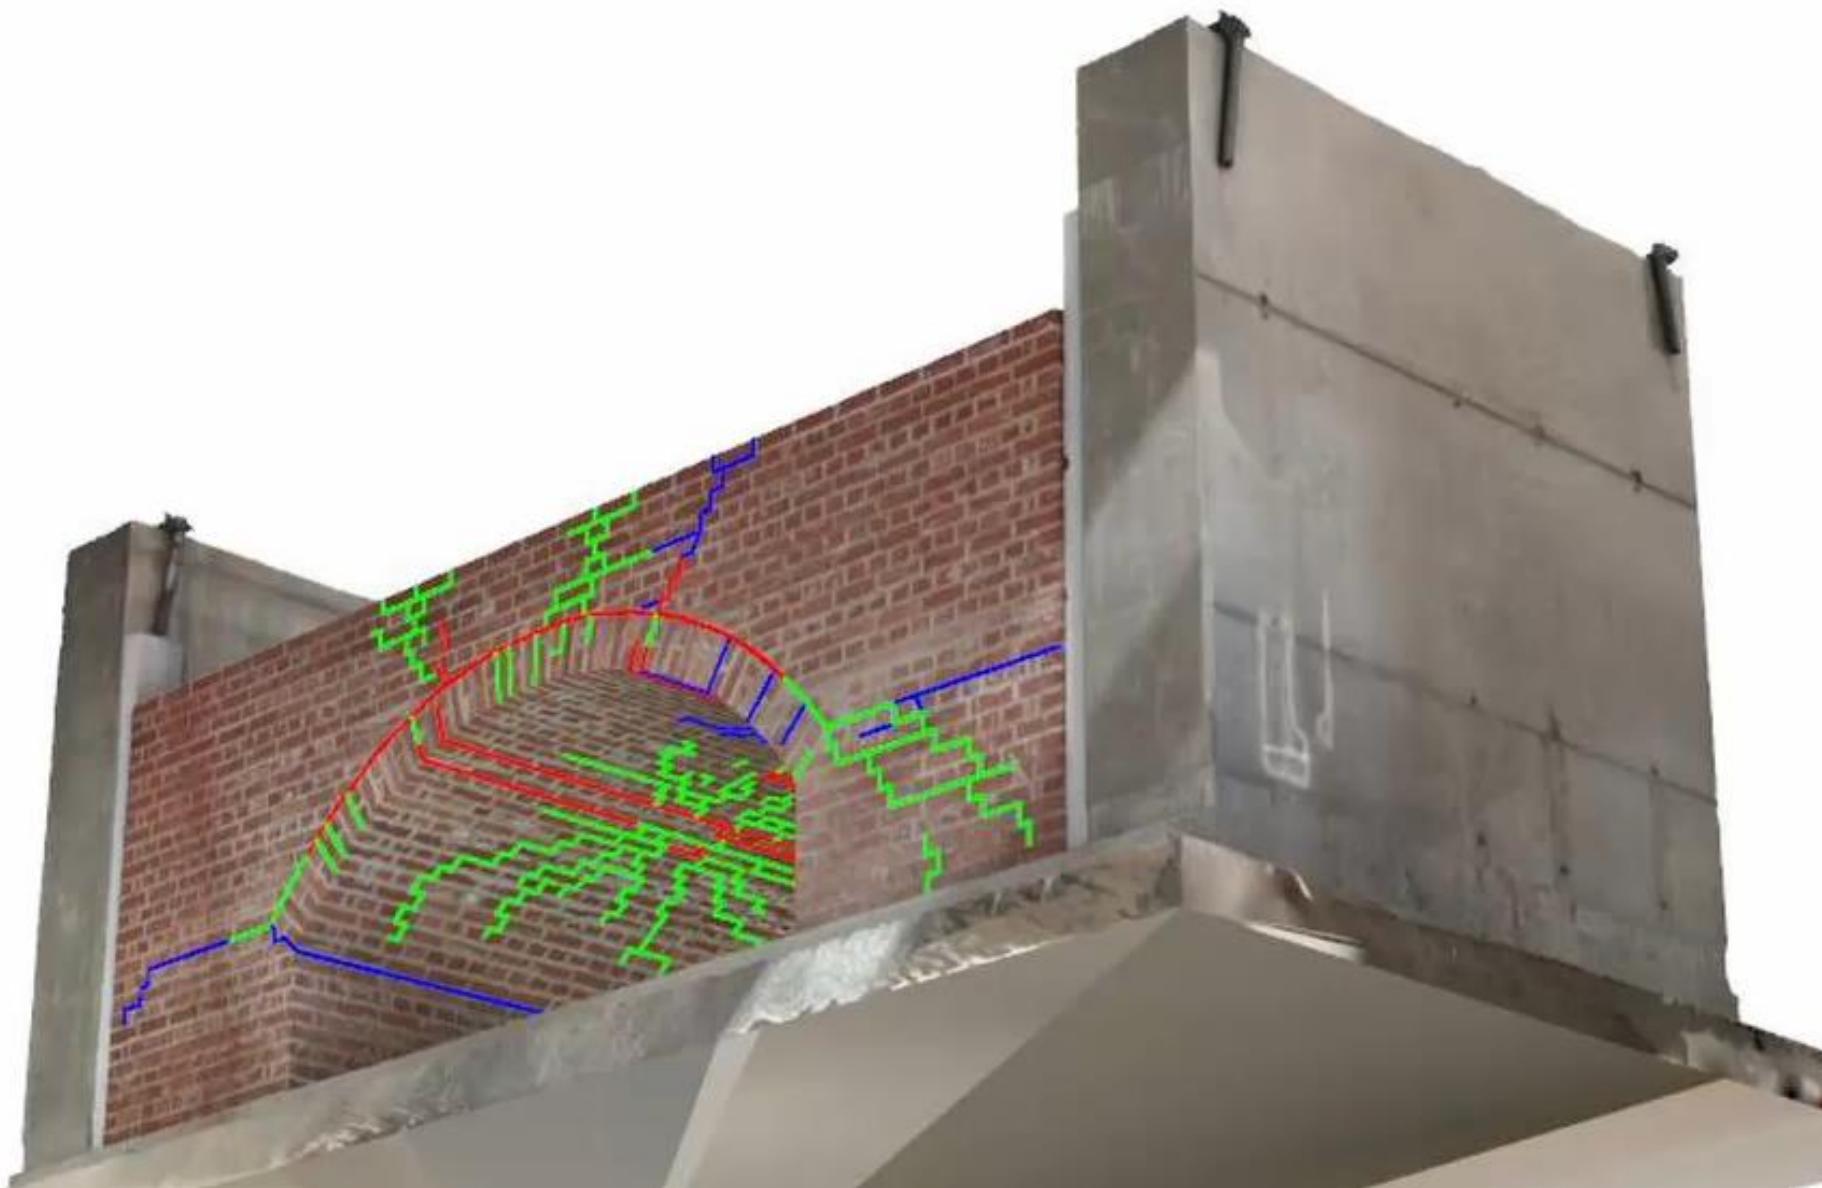
3D Cracking

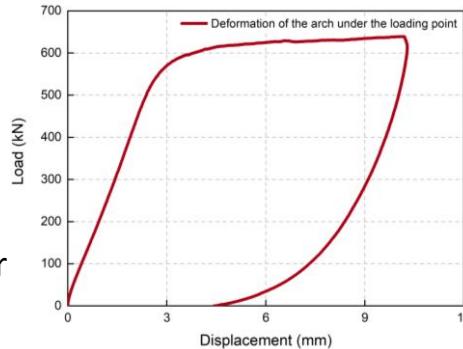
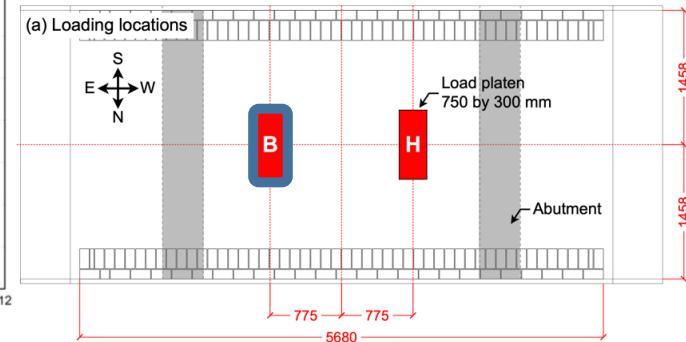
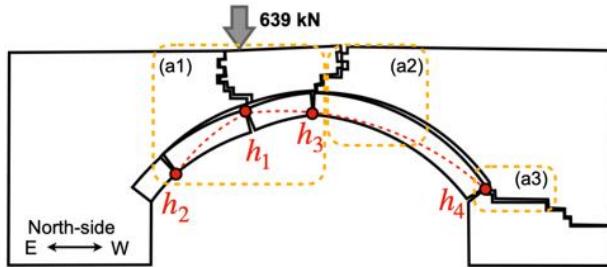
(a) Failure mechanism at T22

- **Loading location:** Point B
- **Peak load applied:** 639 kN
- **Loading area:** 300 by 750 mm
- **Failure mechanism:** four-hinge behaviour
- Hinge-3 at the mid-span region

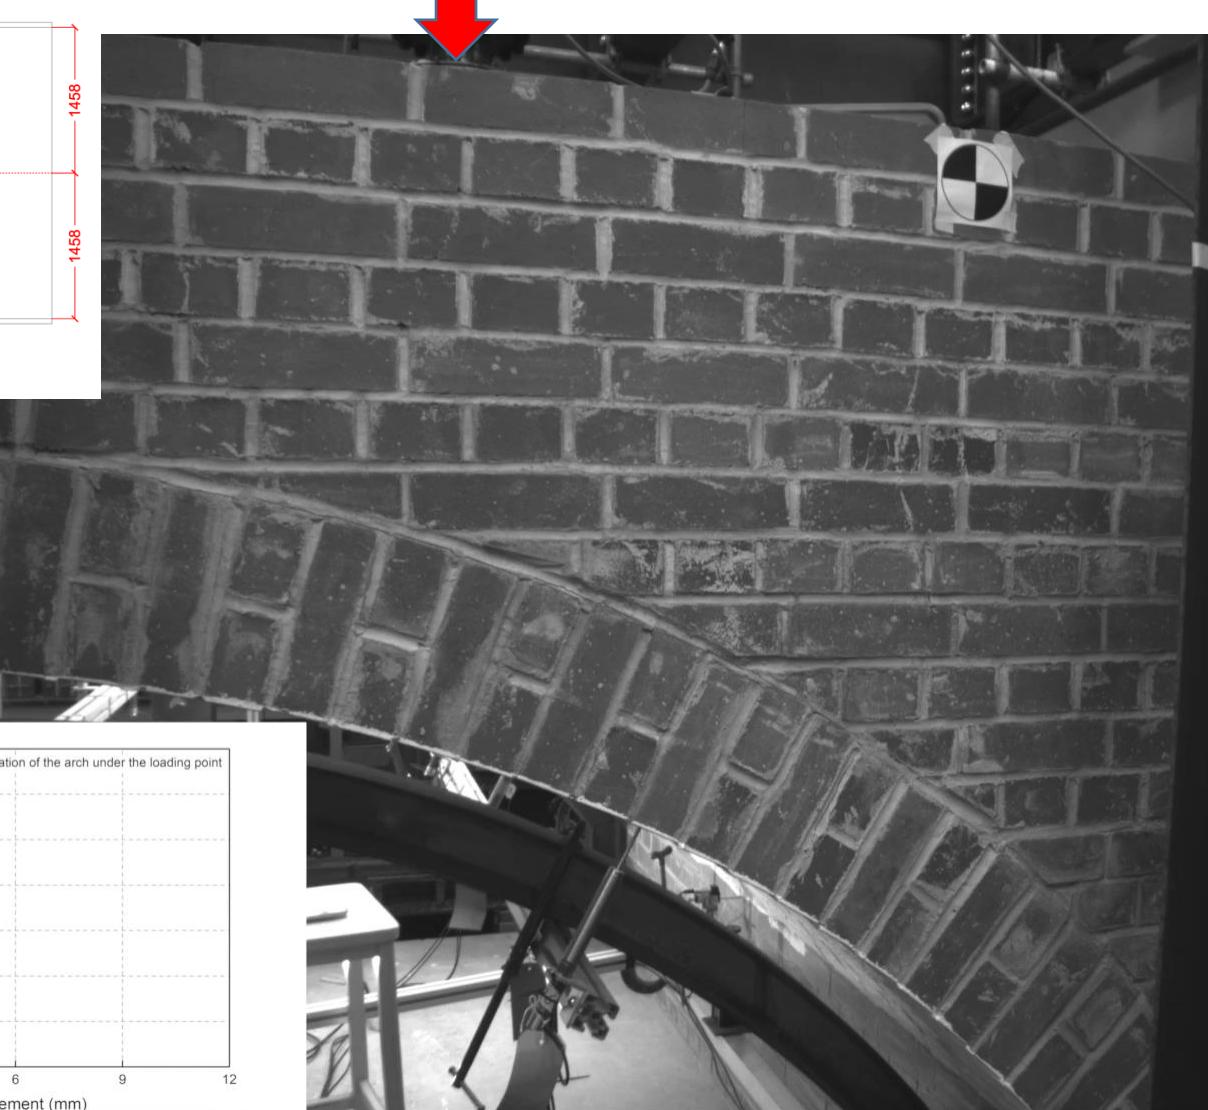
- T22
- 750 by 300 mm platen
- Loading at point B
- South right-hand side wall
- 639kN

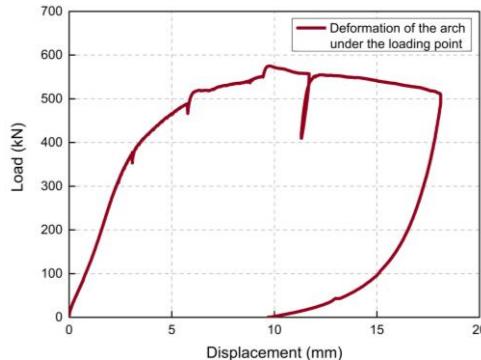
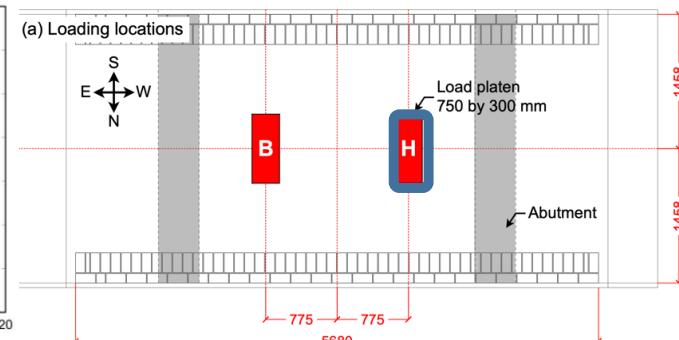
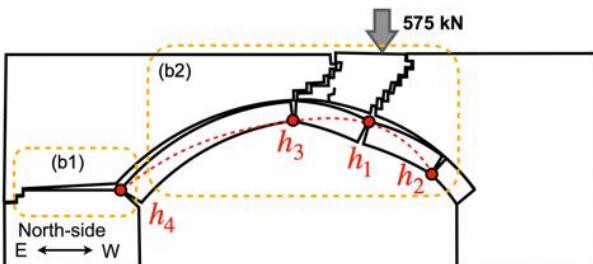
(b) Failure mechanism at T25

- **Loading location:** Point H
- **Peak load applied:** 575 kN
- **Loading area:** 300 by 750 mm
- **Failure mechanism:** four-hinge behaviour
- Hinge-3 at the mid-span region
- Diagonal crack observed in backfill

Crushing of mortar
