Laboratory testing of a full scale masonry arch bridge

Vasilis Sarhosis

School of Civil Engineering, University of Leeds

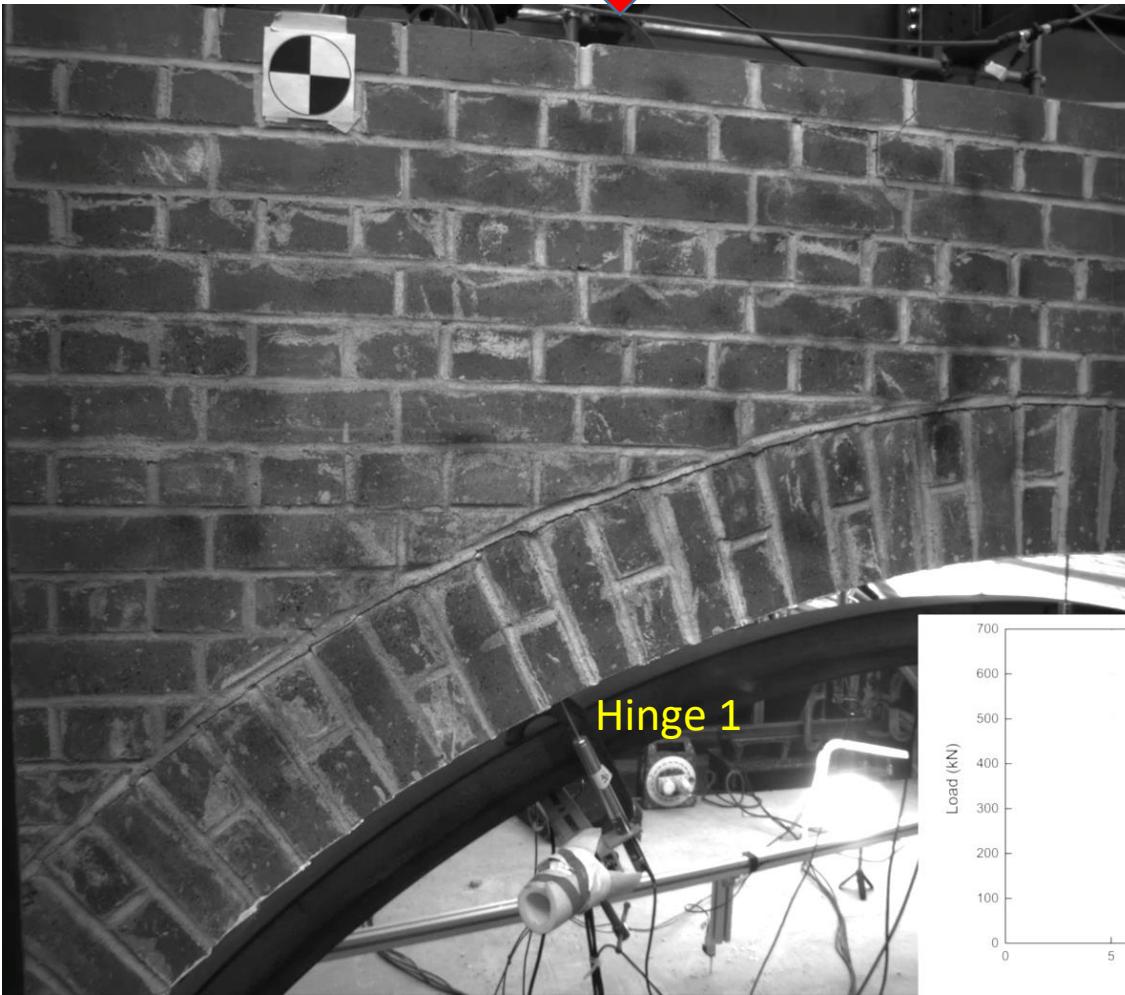
- **Loading location:** Point H
- **Peak load applied:** 575 kN
- **Loading area:** 300 by 750 mm
- **Failure mechanism:** four-hinge behaviour
- Hinge-3 at the mid-span region
- Diagonal crack observed in backfill

- T25
- 750 by 300 mm platen
- Loading at point H
- South left-side spandrel wall

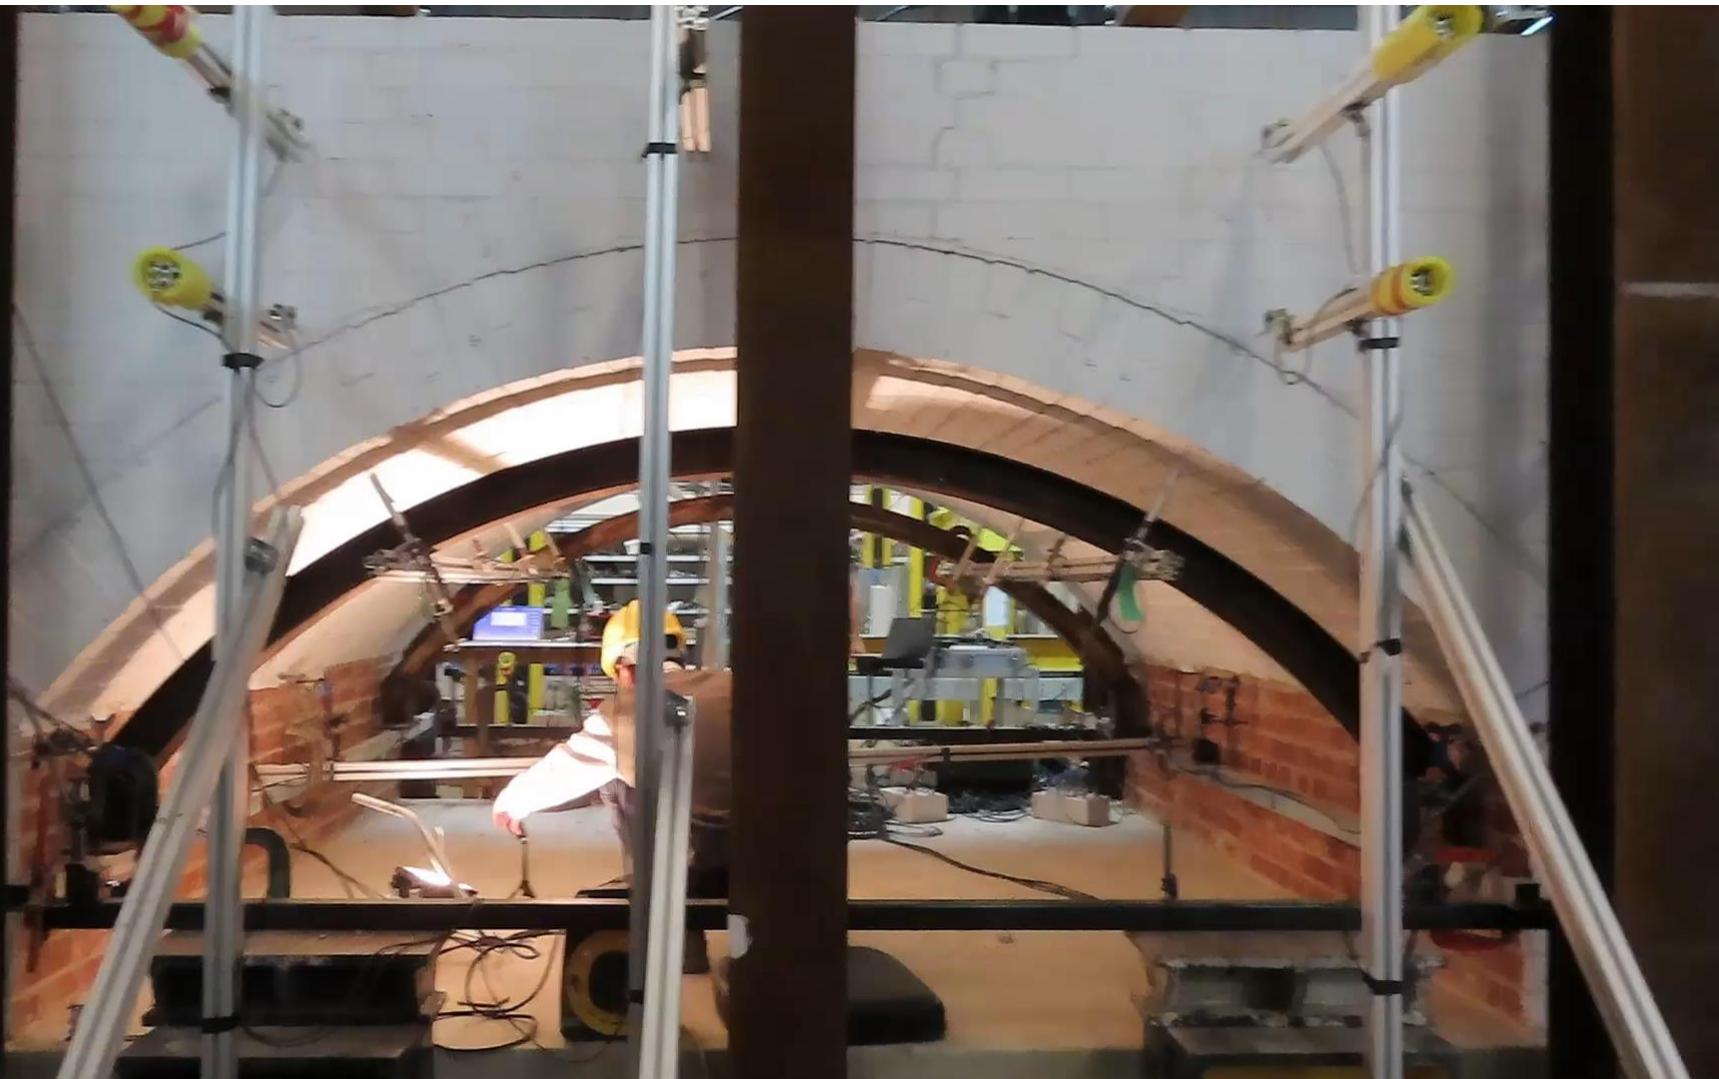
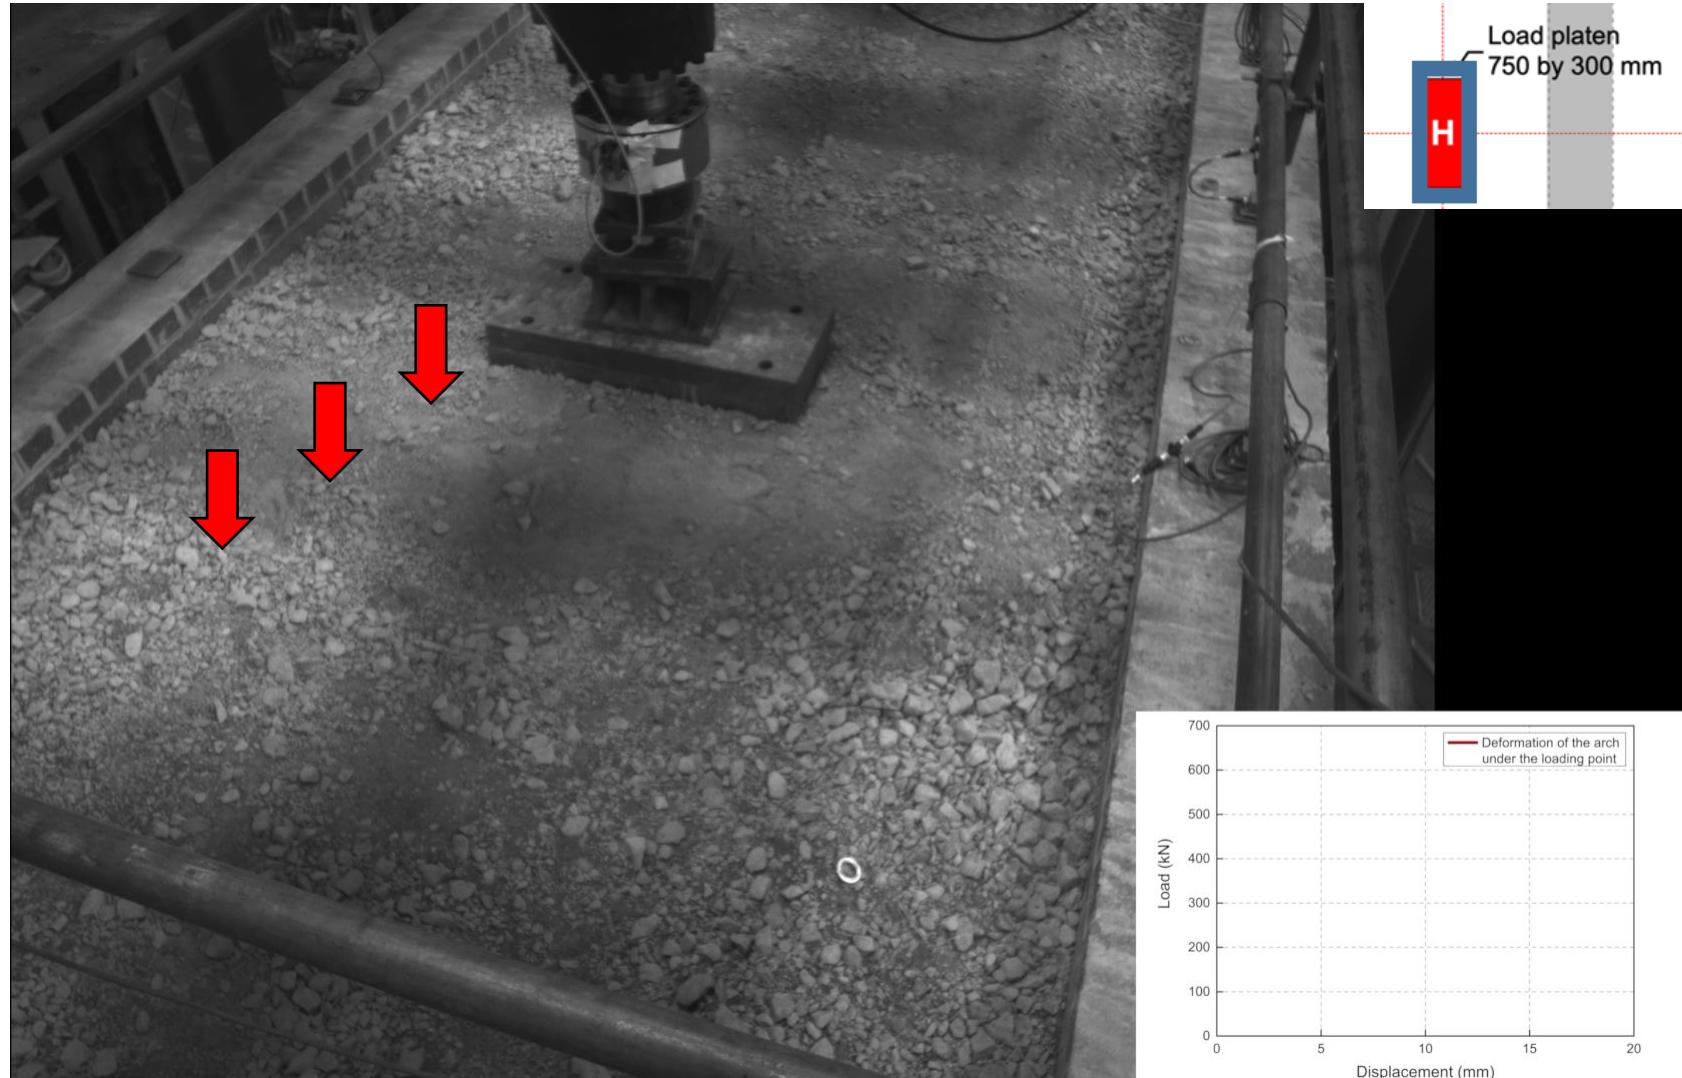
Cracking of backfill

- Point a: reflections denote disturbance to the internal layering of the bridge
- Point b: change to the layering immediately above the arch
- Point c: arch rather less symmetrical after the damage,
- Point d: deflections particularly prominent in the flanks.

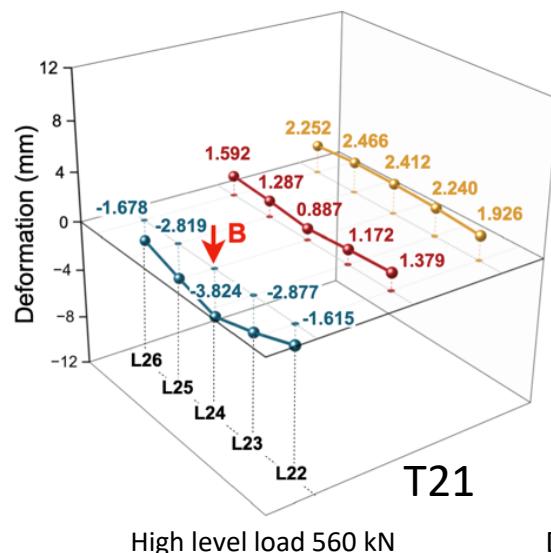
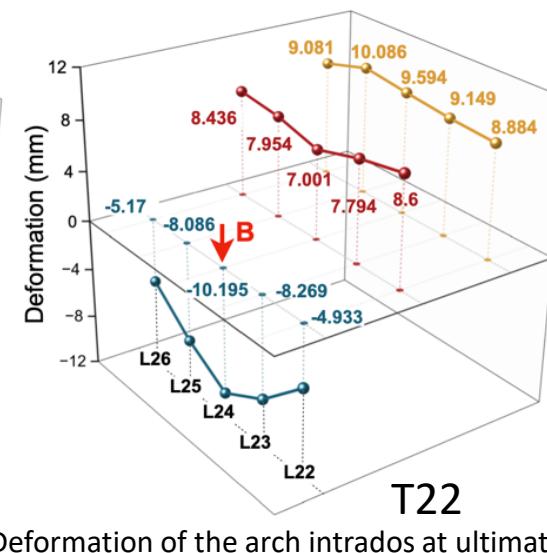
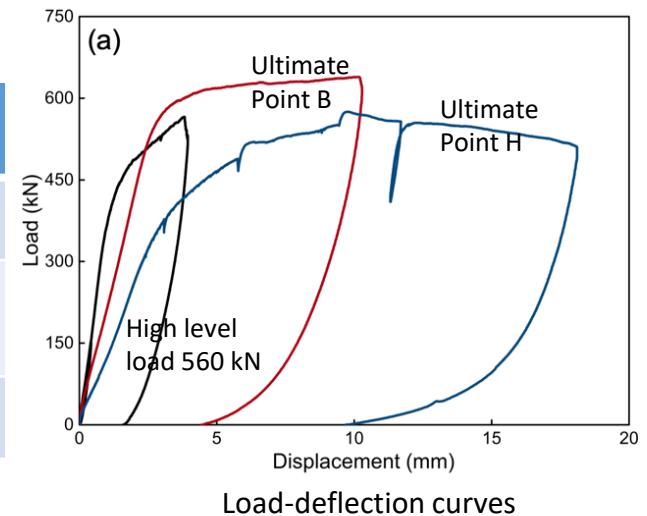
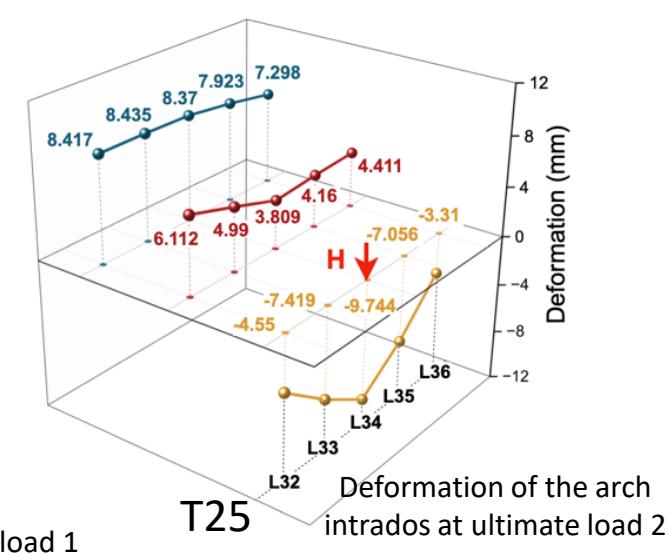
Load-deformation response during the high-level and ultimate tests

3D response was observed in the arch barrel under patch loading

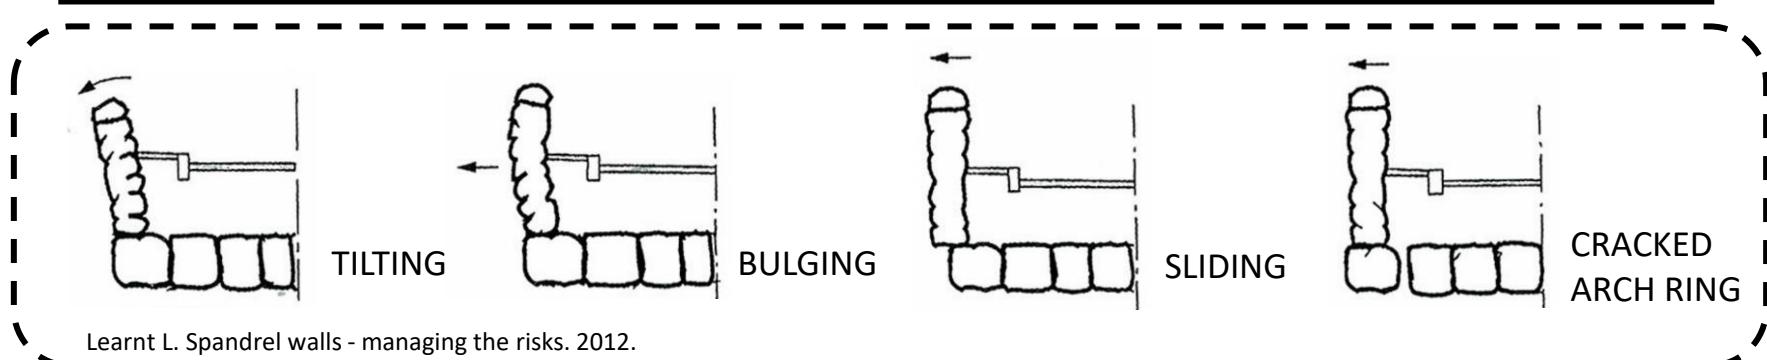
Results: Peak out-of-plane deformation of spandrel walls

Out-of-plane deformation at the peak load (mm)

- When the load applied above the span of the arch, the spandrel walls moved outwards
- Failure mechanism: **combined effects of tilting and sliding**.
- The location closest to the loading had the most significant out-of-plane deformation, as it was subjected to the greatest lateral soil pressure under patch loading.
- Maximum out of plane deformation was approx **1 mm for the high level test, 2.6 mm for the ultimate 1 and 5.3 mm for the ultimate 2**

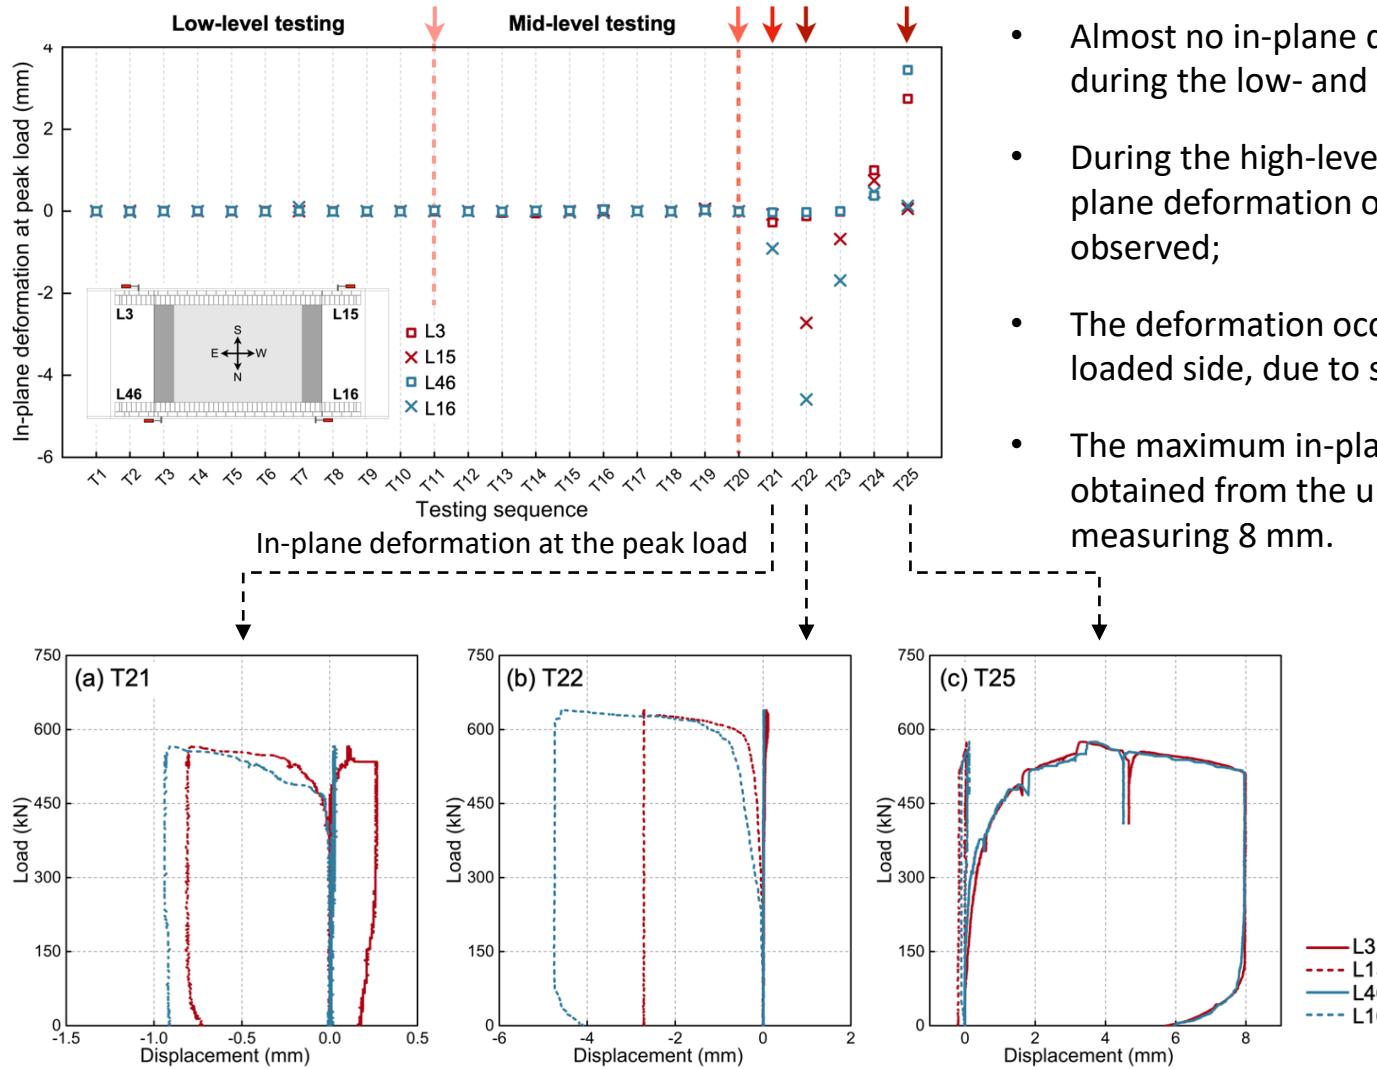
- Almost no in-plane deformation was observed during the low- and mid-level testing;
- During the high-level and ultimate tests, in-plane deformation of the spandrel walls was observed;
- The deformation occurred away from the loaded side, due to sway of the arch barrel.
- The maximum in-plane deformation was obtained from the ultimate test 2 (T25), measuring 8 mm.

Displacement versus in-plane deformation curves for (a) T21, (b) T22, and (c) T25.

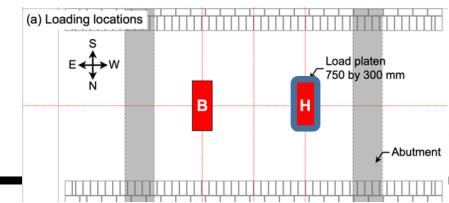
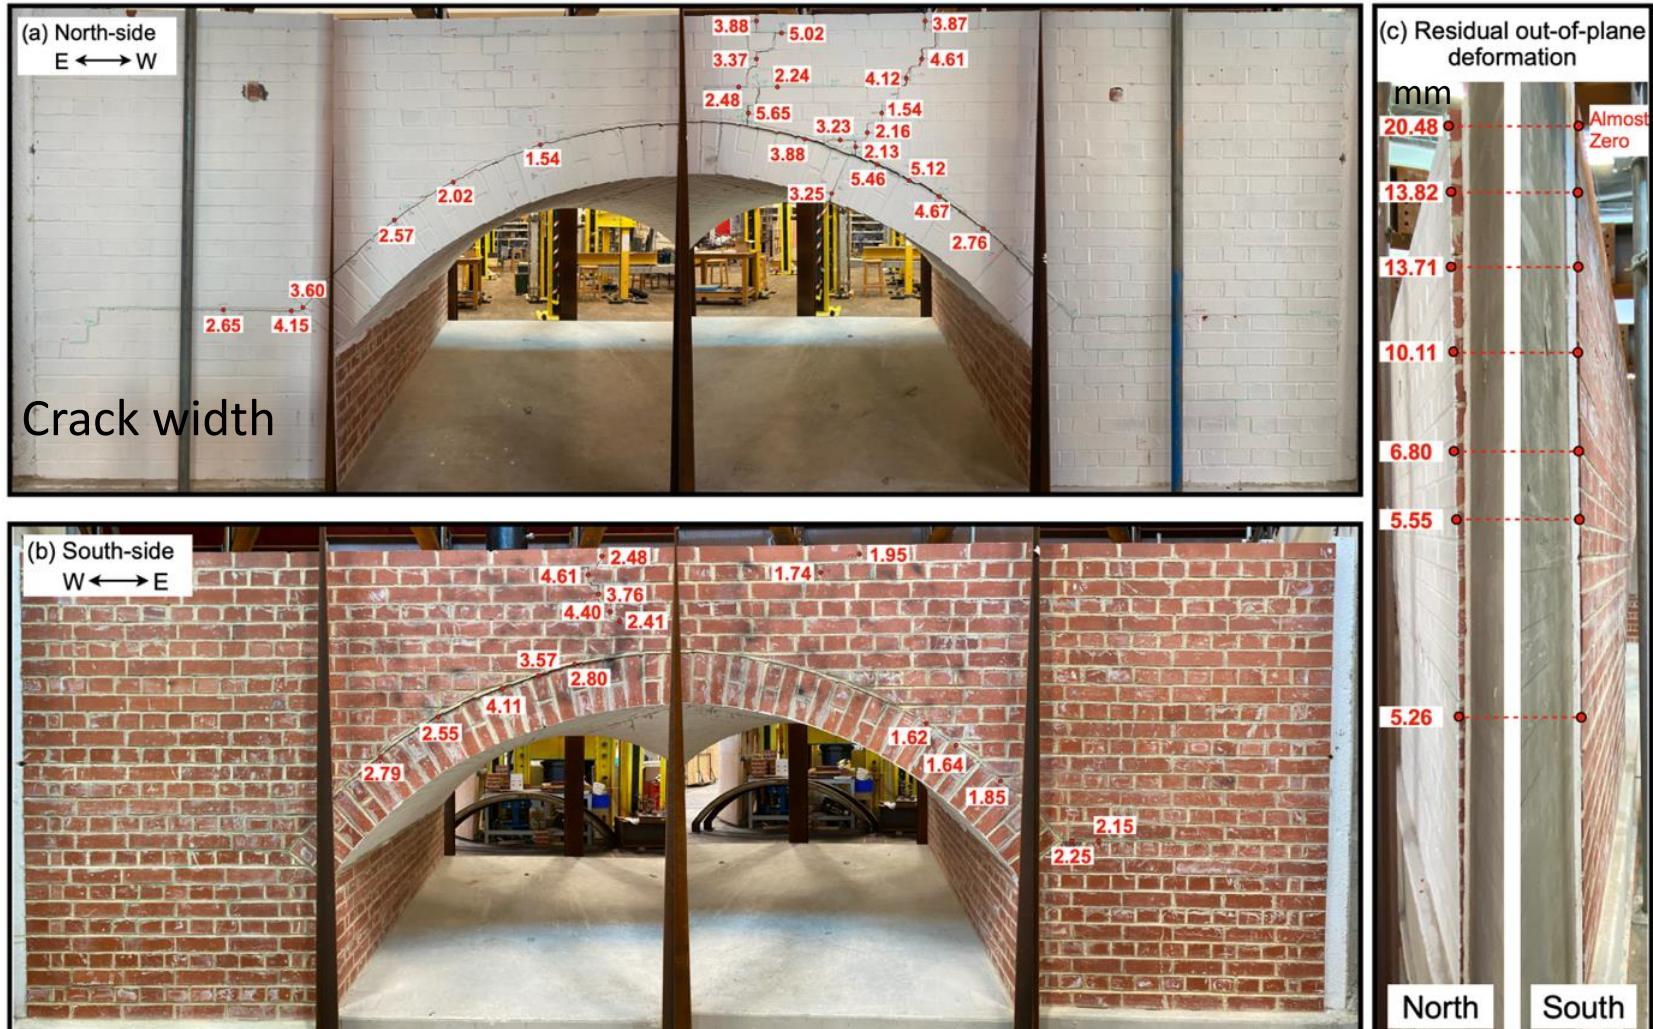
Results: Final crack width (after all tests)

- Damage on the north-side wall was more severe (max crack at hinge 5.46 mm)
- The south-side of wall didn't have any noticeable out-of-plane deformation
